May 2017 – Ric on his own

July 2017 – Andy on his own

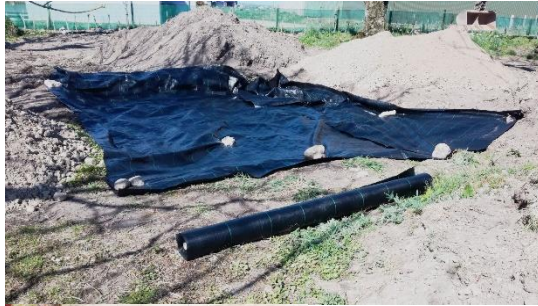
Drains (almost) finished: Ric covered the soakaway with a double

layer of weed membrane then made good with subsoil and topsoil. He laid drains up each side of the courtyard for gutter downpipes. The last job will be to divert our field drain into the surface water drain, possibly next year.

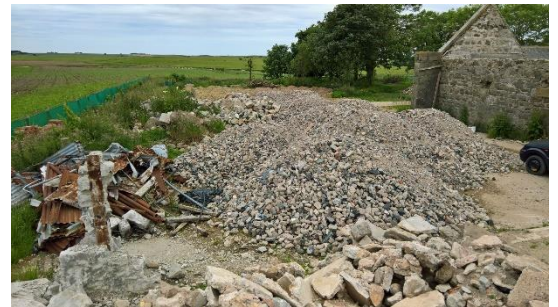
186 tonnes of Hardcore: We had a big pile of concrete and we needed hardcore for our floor slab. George got back to Ric to say that a mobile crusher would not cope with our bigger bits of concrete, he suggested getting crushed hardcore in, with the trucks taking our concrete back with them. It happened, we got 9 truck-loads delivered, all there was room for. We will use over half on

the floor slab and will look to get George to use the rest on the worst parts of our track. There is still a big pile of concrete left over, as well as the remaining hardstandings.

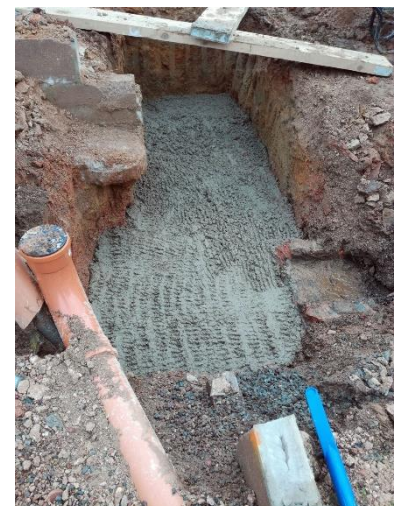
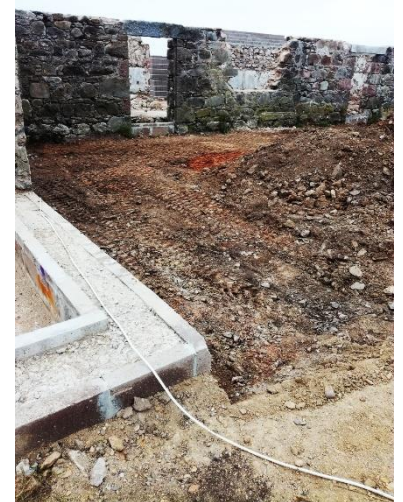
Foundations and field drains: Ric excavated the missing foundation for the north gable-end wall. In doing so he uncovered a second field drain running under the steading, a clay pipe, but bigger than the one we found last year. It looks as though it pre-dates the steading and that the brickwork under our gable-end wall had been put in place much later to divert our near-surface clay field drains into. This would explain the sounds of running water we heard when we bought the property. It went silent round about the time we had our mains water installed, which cut across & blocked the shallow clay pipes, leading in turn to our flooding problems. I now think it is this drain the architect knew about and wanted us to fix, our first one is a bonus.

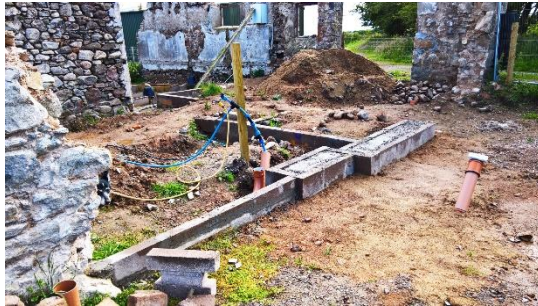
North gable-end foundation:

The blockwork here is a bit fiddly because there is the double-leaf gable-end foundation & the adjoining wall foundation, stepped back by 22cm and also double-leaf. The existing front-door foundation & the internal

foundation, that will bear the upstairs floor joists and roof trusses, stairs and garage wall both need to tie in. I measured where the blockwork needed to be, from every reference point I could, then over two days got four courses, exactly, of blockwork laid, with the double-leaf sections filled with weak concrete. I back filled the inside with weak concrete and the front with soil. Now we just need the walls re-built!

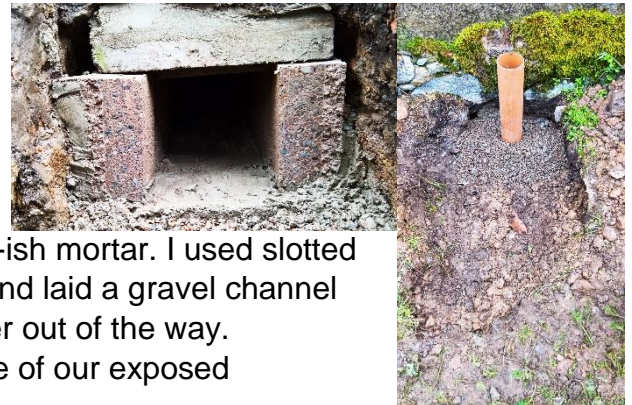
Air-pipe for woodburner: We will need a supply of air for the woodburner. We will run a pipe under the nearest outside wall, up into the hardcore and up through the floor slab. All I needed to do for now was sort out the bit under the wall. I dug out, laid a concrete pad under the wall, put concrete blocks each side, slid lintels on top and packed them with dry-ish mortar. I used slotted (land drain) pipe for the horizontal run under the wall and laid a gravel channel back to our drain, to get any stray rain- or ground-water out of the way.

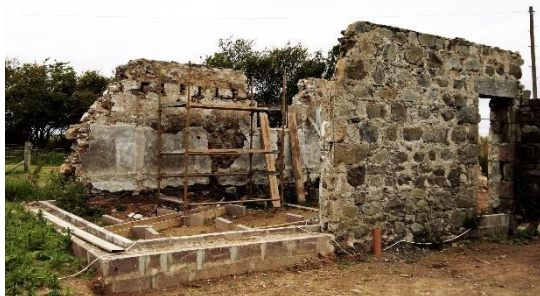
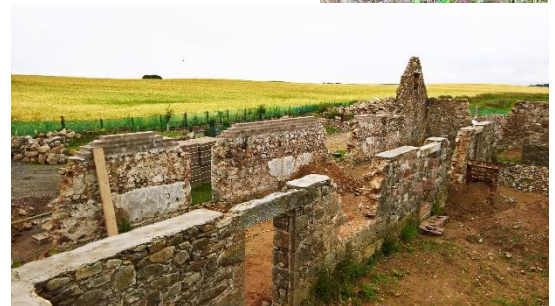
Protecting the wallheads: In April I laid mortar on one of our exposed

wallheads, to protect the them from the weather and to prepare for the blockwork that will support the roof trusses. I got much of the blockwork

done, but had to move on to other things.

I only had time this visit to lay the mortar on the remaining walls. It took 7 short runs of scaffolding, so most of the effort was assembling & dismantling. The mortar was quick and easy to lay and level, with some minor reconstruction work on the walls. I left two bits of wall which need to be partially demolished in the next 12 months.
