## June 2018 – Hedges and Blocks

## July 2018 – Sills, Quoins, Lintels, Rubble

## East Byreleask Steading Conversion – Newsletter 27

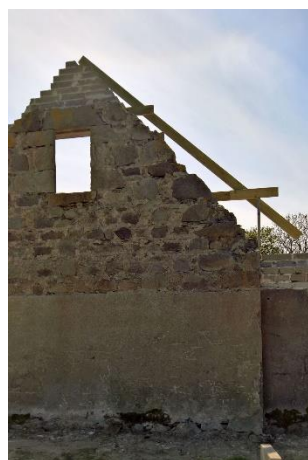
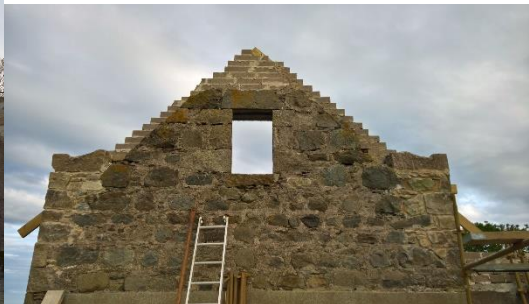
**Gable-end repairs:** The north end of the east wing had been in a bad state of repair. Ric sorted out one side of it in April, installing quoin stones, then the retaining stone that will support coping stones on the parapet at the top, then

running blockwork up the inside edge of the wall. I did the honours this time on the other end of the wall.

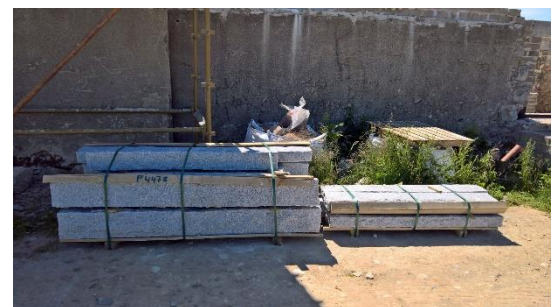
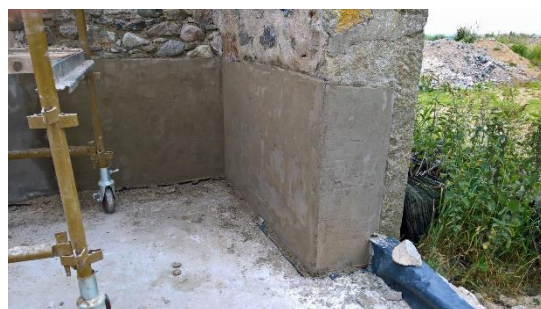
**Lintels:** I tracked them down to our local builders merchants. The bad news? There

were only 18 of the 41 we ordered. The good news? We had the ones that mattered and several days later, the missing ones were traced to somewhere in Liverpool - to join us at some point.

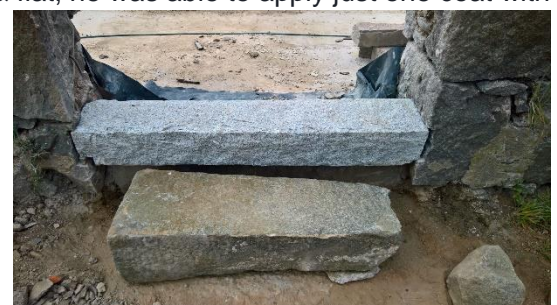
**Door sills:** Ric experimented with the kitchen door onto the courtyard. After much measuring up, he chiselled out grooves in the quoins at the base of either side of the door opening, cut one of Jill & Andy Walker

our 150mm lintels to length, then trimmed the ends of to match the grooves. He simply slid the completed sill into the grooves. Very neat. About a half-days work. We will mix up concrete to build up under the sill and to set the doorstep into place.

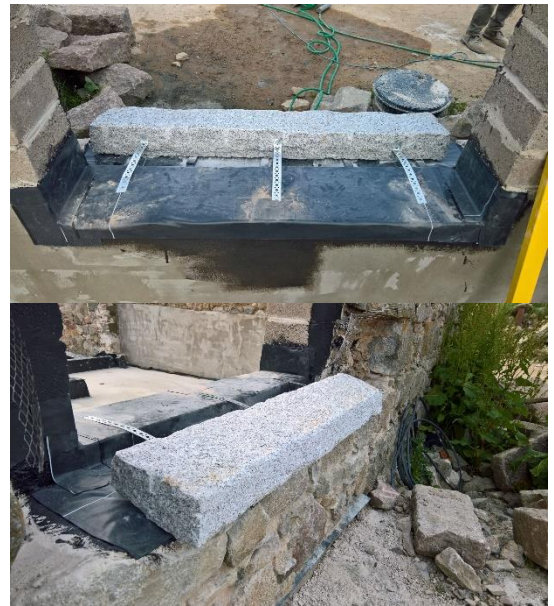
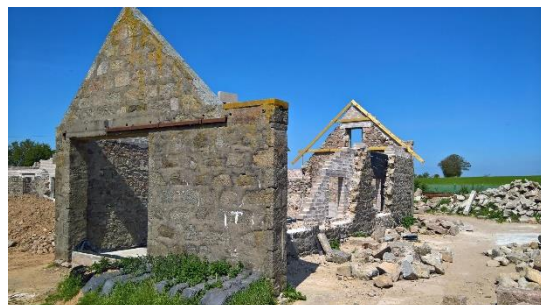
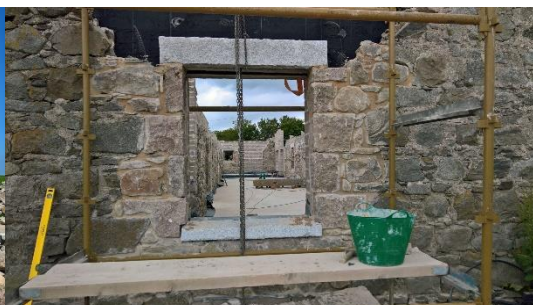
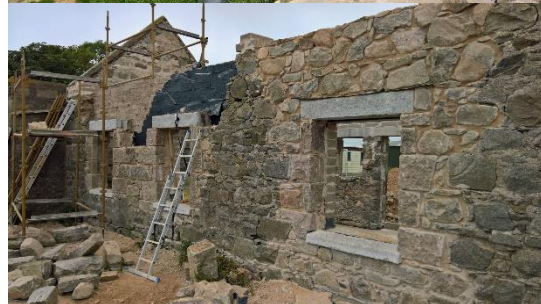
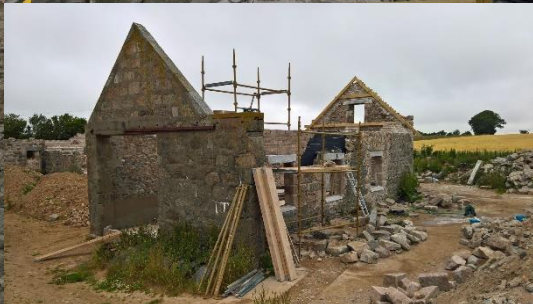
**Windows sills:** He tested out his ideas for sills on the main bathroom window. It needs to slope on top to shed rain water, so he used the angle grinder to trim the front face to the vertical, then bush-hammered it to get a roughened finish. He cut the projecting underside of the sill to horizontal and cut a drip groove along. He made a little wooden jig to guide him in trimming rough areas off the rest of the underside, to allow it to lie flatter. About 2 hours work per sill, for an excellent rustic finish. We used self-adhesive tanking membrane over the width of the window opening and ran it just over the inside wall, so that when we tank the bottom 1m of wall it will lap over and form a continuous barrier to water. We rested the sill on strips of double-sided adhesive foam, to spread the load evenly across the sill, then screwed steel straps from the back of the sill onto the concrete blockwork behind the sill. These stop the sills from sliding forwards. It all worked really well, we can squirt foam under any gaps under the sill when we are ready.

**Window openings and rubble walling:** With one sill in place I could get going with quoin stones, overlapping onto the top of the sill by 30mm or so each side. I built back from each quoin to the original granite wall. Then after a day, for the mortar to go off a bit, we put the final concrete structural lintel in place and one of our new granite lintels in front,

with a gap that we filled with concrete. We waited another day for it to go off, then built up courses of granite rubble above the lintels, up to the original wallhead. We worked on the other two window openings at the same time. By the time I drove back southall three had sills, quoins and lintels.
