September 2018 – Roof Trusses

East Byreleask Steading Conversion – Newsletter 27

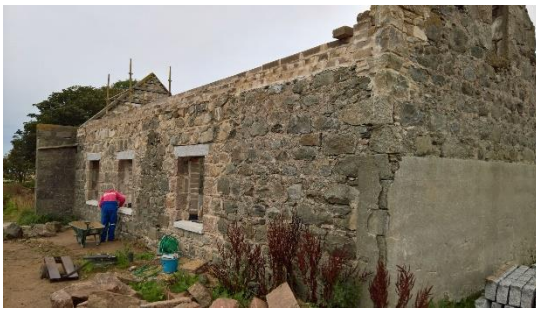
Wallheads – we finished the four courses of concrete blocks along the east wing walls, that raise the roof to the designed height. Over that we laid the timber wallplates onto a thin bed of mortar and screwed them to the blocks.

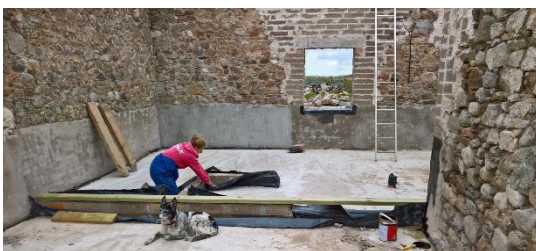
Timber studwork – There is no wall where the north and east wings join, so we needed to build structural studwork across the gap to support the

attic trusses from underneath. Jill unwrapped damp proof membrane (DPM) from the foundation blocks we installed back in 2016, laid a damp proof

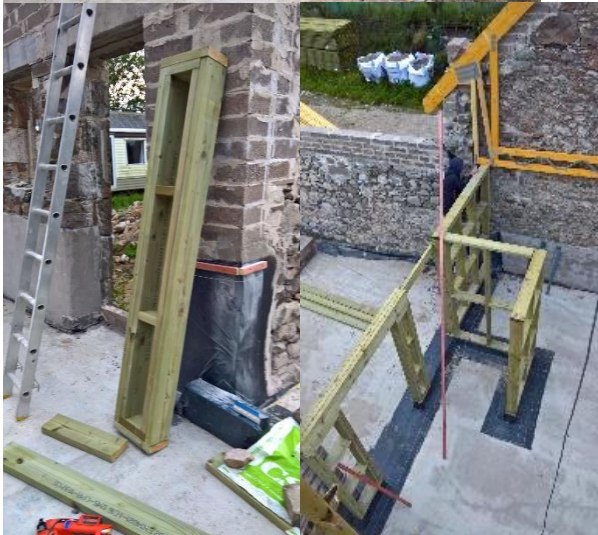
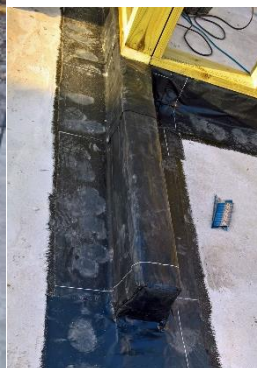
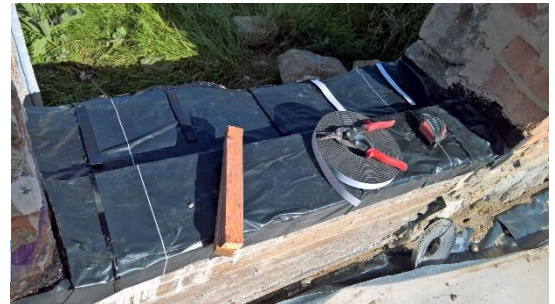
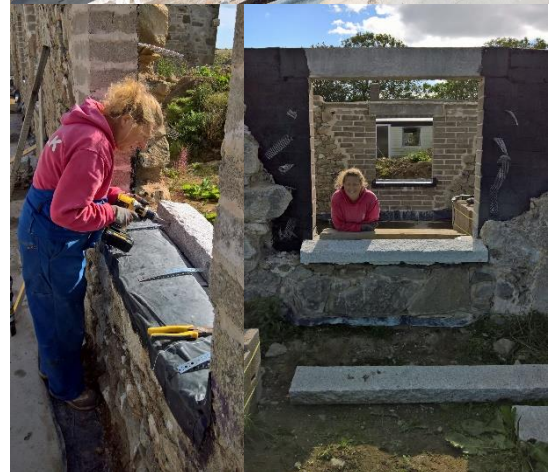
with the DPM. Then for good measure we covered it all with a layer of our rubbery tanking membrane – the blockwork ended up with a bit of a Michelin Man look to it! Ric cut lengths of timber to size,

dunked the cut ends in preservative and we used our nail gun, for the first time, to put it together in sections. The gun is a bit unwieldy, but is quite fun to use and we got 500+ nails done in an hour and a half. The next day we stood the sections up, nailed them together and screwed them down to the foundation blocks. And that was that.

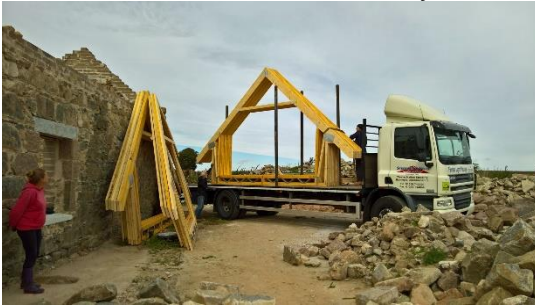
Attic trusses in the east wing – We developed a routine for handling the trusses. We loaded both ends of each one onto trolleys and screwed a batten to the top, to hold it upright. We wheeled them round to our big window, where we could just slide them through at 45 degrees, then push them upright once they were inside. We had a section of scaffold on casters and used our hoist to lift each truss off the ground until the ends of the rafters were above the wallplates. We pushed the scaffold round towards the installed trusses, and dropped the truss into the clips. It was rarely as smooth and

simple as it sounds and it took us longer than we expected, but we got there. We used angle-brackets to fix the first one to the gable wall, then battens across the truss collars (the horizontal bars at upstairs ceiling height) to hold all the

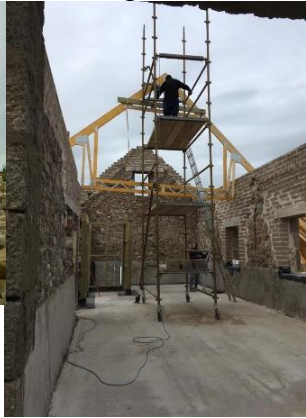
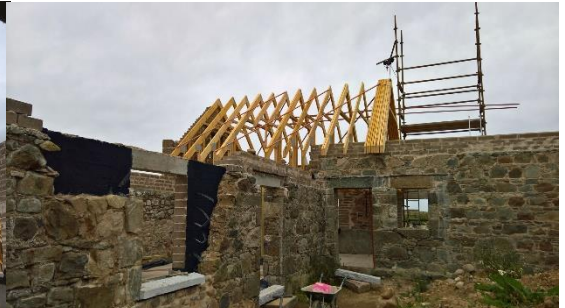
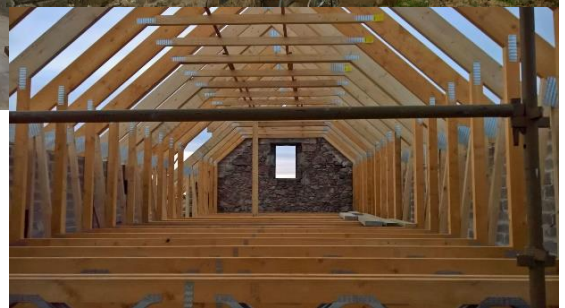
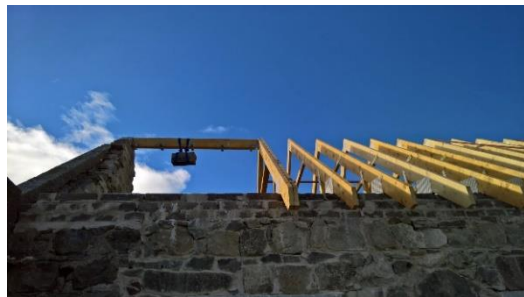
others in place. We temporarily fixed diagonal battens across the rafters to keep it all rigid, particularly

through Storm Ali, with gusts over 70mph. The east wing has a gallery and open void from floor to roof at the south end, so the last few metres of roof structure is a pair of ridge boards that support rafters down each side. Ric did these after we headed back south. So we have a complete roof structure on our east wing.

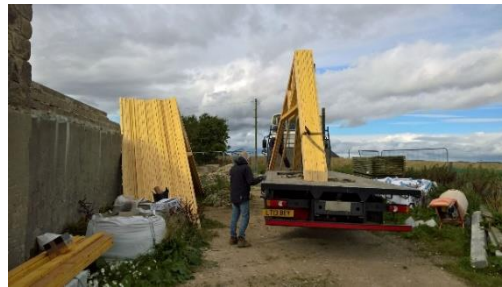
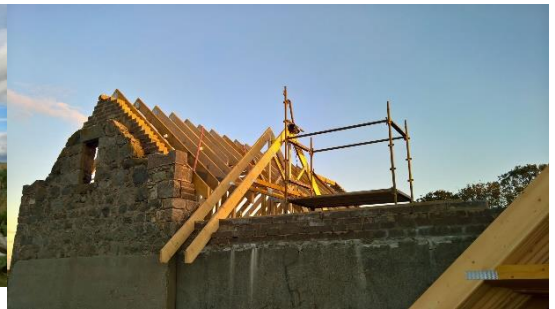
Raised tie trusses on the north wing – our last day on site was getting Ric set up to work on his own. We got the first truss prepared, lifted over the wall and manoeuvred into position at the join with the east wing, nailing it to the ends of the rafters on the attic trusses. We put the second truss up and secured it with batten. We have the timber kit to finish tying the two rooves together and it will be comparatively straightforward for Ric to continue building the north wing roof.
