April 2016 – Build & Demolish

East Byreleask Steading Conversion – Newsletter 20

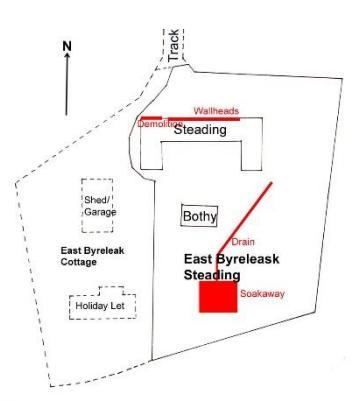
Progress up to our arrival: Ric had done more on our surface water drainage. Most of the downpipe sockets are in place, he levelled-up

the trenches from last September and dug out our 4m x 4m surface-water soakaway. On top of this, he had done extensive levelling and disposal of waste. He has built up the ground leading to where our raised-mound soakaway (from the septic tank) will need to be - the mound should blend quite nicely into the view from the steading.

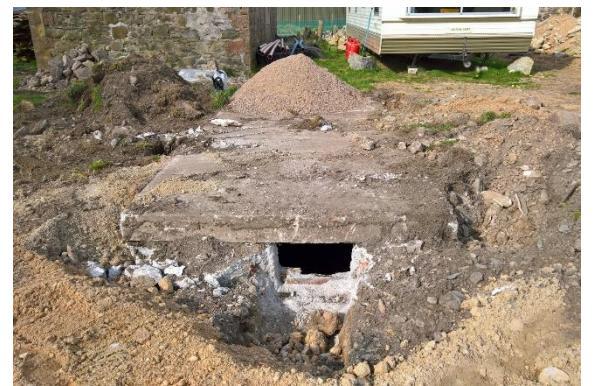
The concrete tank: The creepiest discovery to date was that our 2m x 3m shed base below a thin layer of soil was actually the reinforced concrete lid of a ginormous underground tank. Ric chiselled his way through to discover it was 2.5m deep and had a concrete partition down the middle. It was fairly full of water, with a thick layer of sludge at the bottom. He used our dirty-water pump to get most of the water out and is talking of getting inside to clean it out – we are not quite so keen. Each half of the tank had separate runs of clay pipe

entering from the steading courtyard and at least one run of clay pipe drains out into the wide shallow ditch that ran right down the garden. It was probably tied in to the drainage of the now-removed silage clamp built against the north side of the steading building.

Ric talked us into running our surface water drain through it, so that we have a reservoir of garden water that we can pump out.

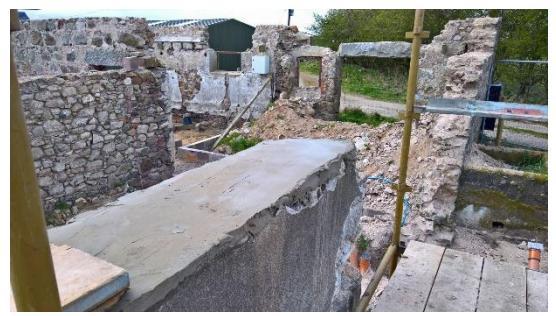
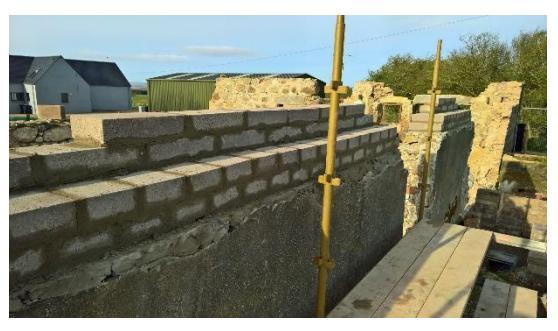
wallheads for a new roof (and protect them from the weather), even though the door and window openings have not yet been squared up. When they are, we will install lintels over the openings and bind them into the blockwork that will hold the roof trusses.

We checked that each pair of wallheads are 1) level, 2) straight and 3) parallel. The only real problem is the east, two-storey,

stretch, where one wall is straight, but the other has a 12cm curve outwards at one point. We will need tweak the blockwork so that the two sides end up parallel.

We chose start capping the north stretch, because it is low, level and parallel. We made up barrows of 1:4 mortar and slathered it over sections of wallhead, to produce a level, horizontal surface. After a day for the mortar to go off, we lugged 100mm concrete blocks onto the scaffolding and laid two courses, lengthwise across the wallhead, lined up with the inner face of the wall. Then two courses lengthwise along the wall. So the inner face of the wall is raised by 400+mm and the roof trusses will rest on top. Fate intervened and we had to move on to other work, but at least we have done some real building!

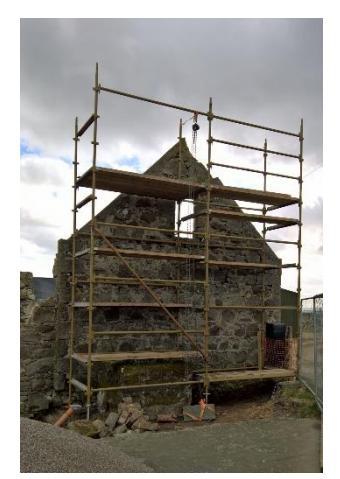
Demolishing the un-supported gable-end wall: The 'other work' was to take down the wall that

is to have our garage door in it and which is without foundations at one end. We rescued the dressed-granite capping stones, put them to one side and picked our way down the rubble-build wall. Large stones got hoisted down, medium stones we lugged down by hand, small stones we threw down. It was slow to start with and speeded as we got lower. The last few courses we did not need the hoist, but the stonework got noticeably harder to prise apart. We pulled the unsupported section down by hand, from ground level and cleared it to ground level. We stopped at the point Ric

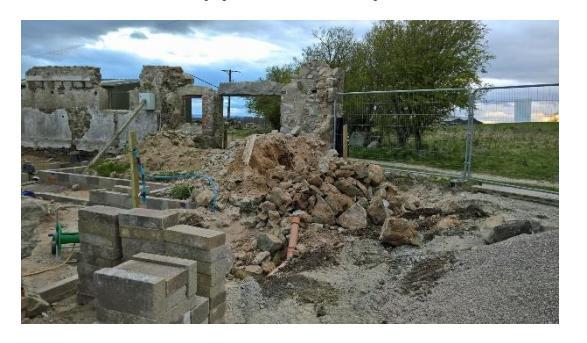
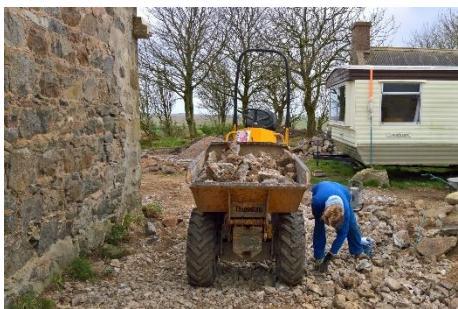
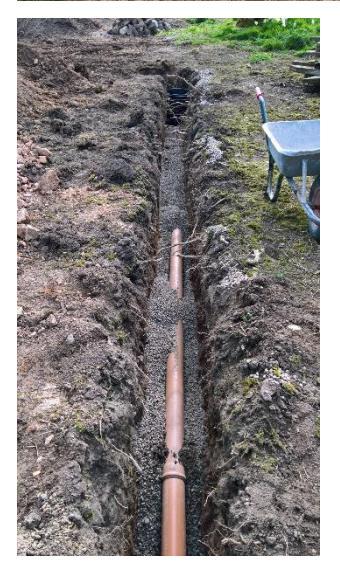
Filling the soakaway: With the wall down, the next priority was

to fill the soakaway with suitable rubble. We scoured the site for loose odds & ends, then got down to serious hard labour. We took all the broken hardstanding (i.e.

and smashed it up with a sledge hammer. After two days of barrowing, we got the mini dumper back and used that. When the breakable concrete in our big pile ran out we got Ric to pull up more concrete in the courtyard. So after 4 days we at last got all 16 cubic metres of soakaway filled. The rubble was very effective, it did not compact down and left plenty of voids. We ordered some 4m wide weed membrane, Ric will lay two layers of it over the rubble, put subsoil on the membrane and finish off with some topsoil. Job done, hopefully never to be seen again!

Running drains to the soakaway: Ric meanwhile ran trenches from the soakaway up to the current end of our pipework. We laid the drainpipe in gravel, projecting into the middle of the soakaway, levelled it up, then refilled the trenches. He did indeed run the drain pipe into one side of the big concrete tank and out the other side and connected to the system we
